# Mineral Fibre Loft Insulation, Workmanship, Ventilation & Condensation

*A White Paper*

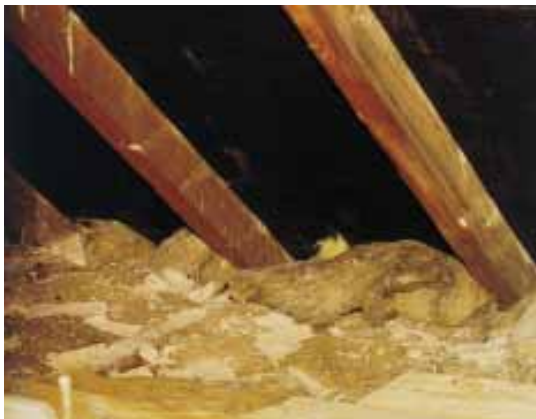
Image 1

**4.1** All properties had some degree of blocked ventilation paths due to overfilling of the eaves and typically the majority of the spaces between rafters at the eaves were completely blocked by the mineral fibre quilt. In many cases the mineral fibre had been laid in such a manner that it contacted the underside of the sarking felt across the entire space between rafters. The majority of units were found to have 80% or more of the ventilation spaces filled with mineral fibre quilt.

This image is of property #37 Street A. It shows mineral fibre blocking eaves ventilation.

**6.7** A more improved method would be the installation of proprietary eaves vent trays under which the mineral fibre quilt could be tucked, thereby maintaining the continuity of insulation whilst not impeding ventilation.

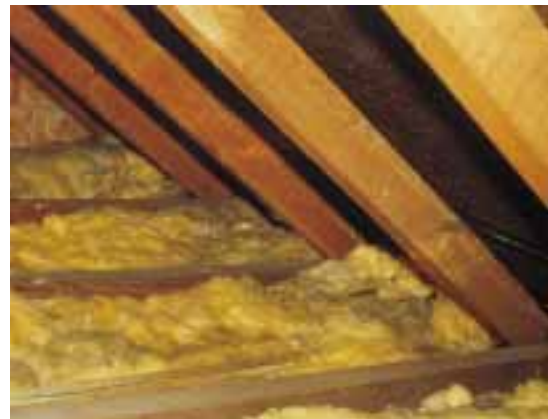
Image 3

This image is of property #4 Street B. It shows mineral fibre blocking eaves ventilation.

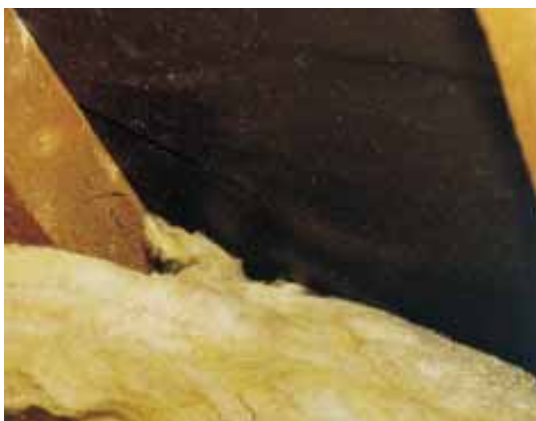
Image 2

This image is of property #57 Street A. It shows mineral fibre blocking eaves ventilation.

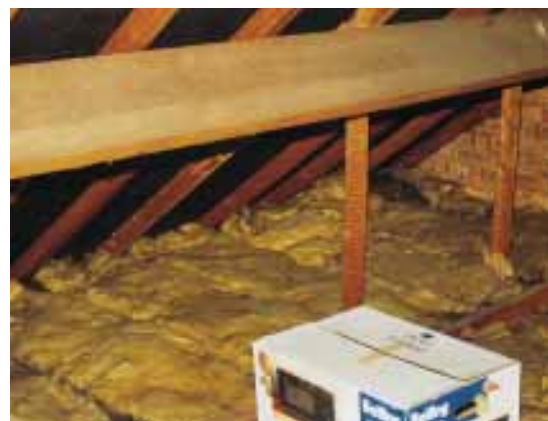
Image 4

This image is of property #36 Street B. It shows mineral fibre blocking eaves ventilation.

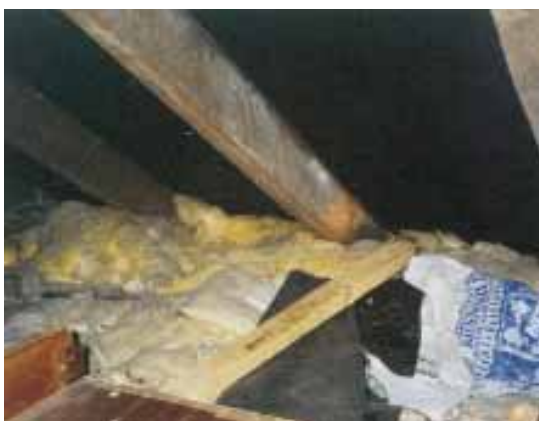
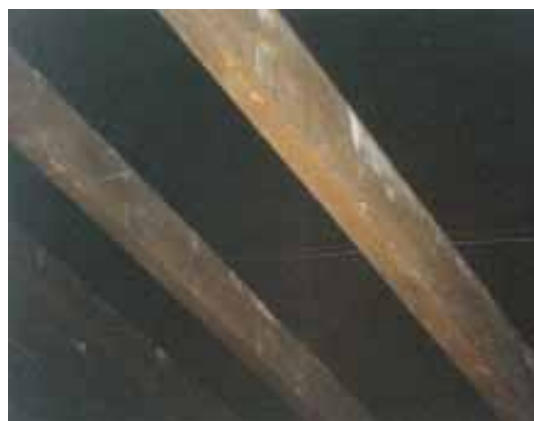
Images 5 & 6

inspection was low (10% by weight). Areas of such moisture staining can be seen in images 5 & 6 below. In general the moisture content of the roof timbers ranged between 10-13% by weight.

These images are of property #65 Street A. They show moisture staining of timber rafters.

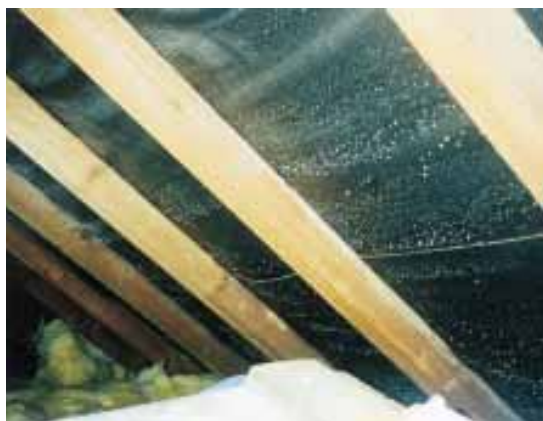
Image 7

This image is of property #47 Street A. This image shows condensation occurring on the underside of the sarking felt covering the entire space between rafters. The droplets ranged between 5-10mm.

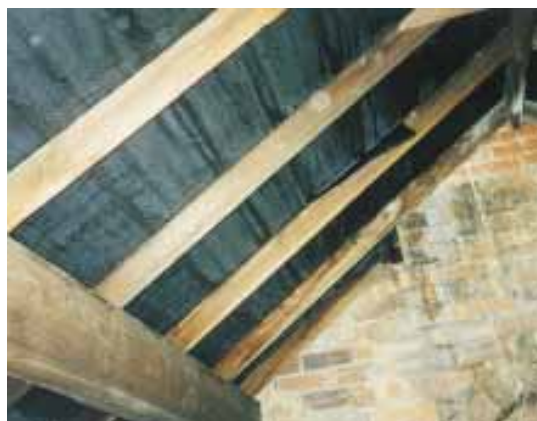
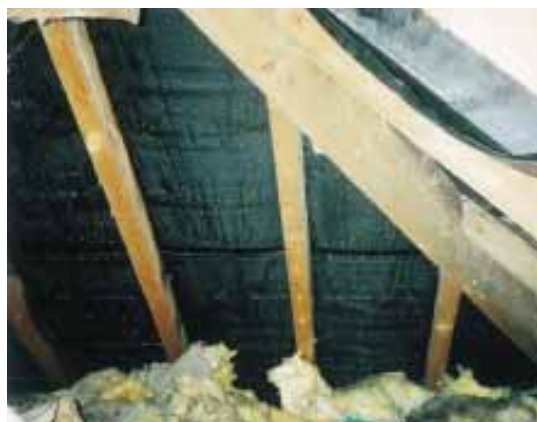
Images 8 & 9

**5.4** In general, the condensation was concentrated on the sarking material around the lower levels of the roof spaces adjacent to the eaves. In most properties it appeared that the higher surfaces, being slightly warmer due to the stack effect, had little or no formation of condensation, although condensation up the entire roof pitch from eaves to ridge could be seen in #37, 51, 57 and 76 Street A.

These images are of properties #51 & 57 Street A. They show condensation occurring on the underside of the sarking felt with a greater concentration of droplets around the lower levels of the roof space.

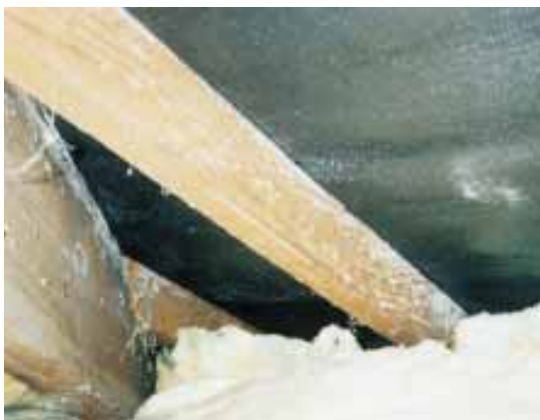
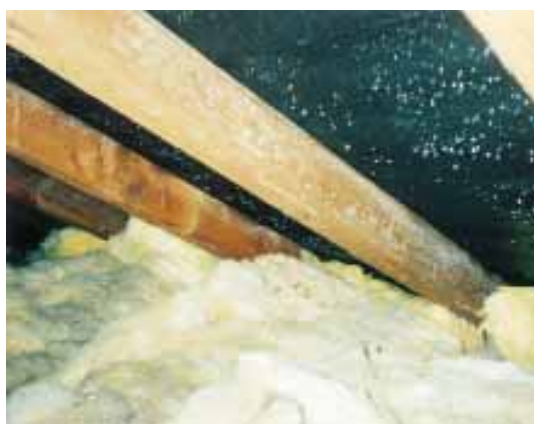
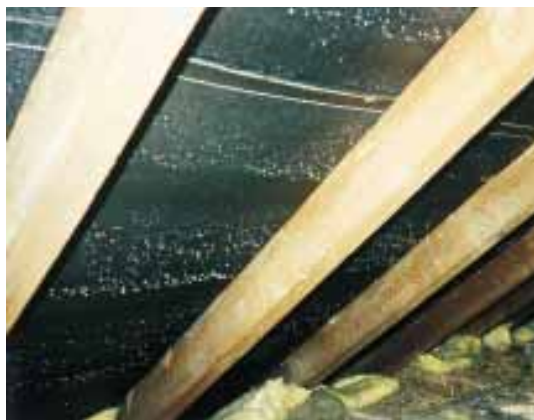
Images 10, 11 & 12

These images are of properties #81 & 83 Street A. They show signs of mould growth on rafter sides.

**5.7** Signs of mould were identified on the rafters in four of the seventeen properties surveyed. (#47, 81, 83 and 90 Street A.) In each loft affected, the mould was forming on the side of the rafters adjacent to those areas with the most severe condensation.
