# Mineral Fibre Loft Insulation, Workmanship, Ventilation & Condensation

*A White Paper*

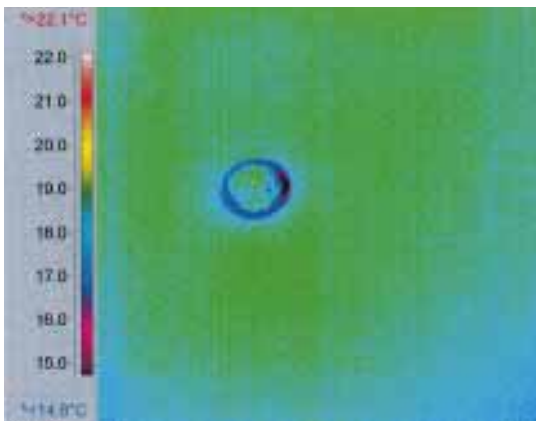
Image 13

The even surface temperature indicates a well performing Kingspan Insulation warm pitched roof system. The small circular shape in the centre of the image is a spot light fitting which is switched off.

**7.2** One of Kingspan Insulation’s products for pitched warm roof insulation can be used. The products are Kooltherm K7 Sarking Board and Thermapitch TP10. A typical thermographic image of a roof so insulated are shown below.
